TOWN OF MEDFIELD

Municipal Facilities

Evaluation and Capital Plan

October 6, 2017

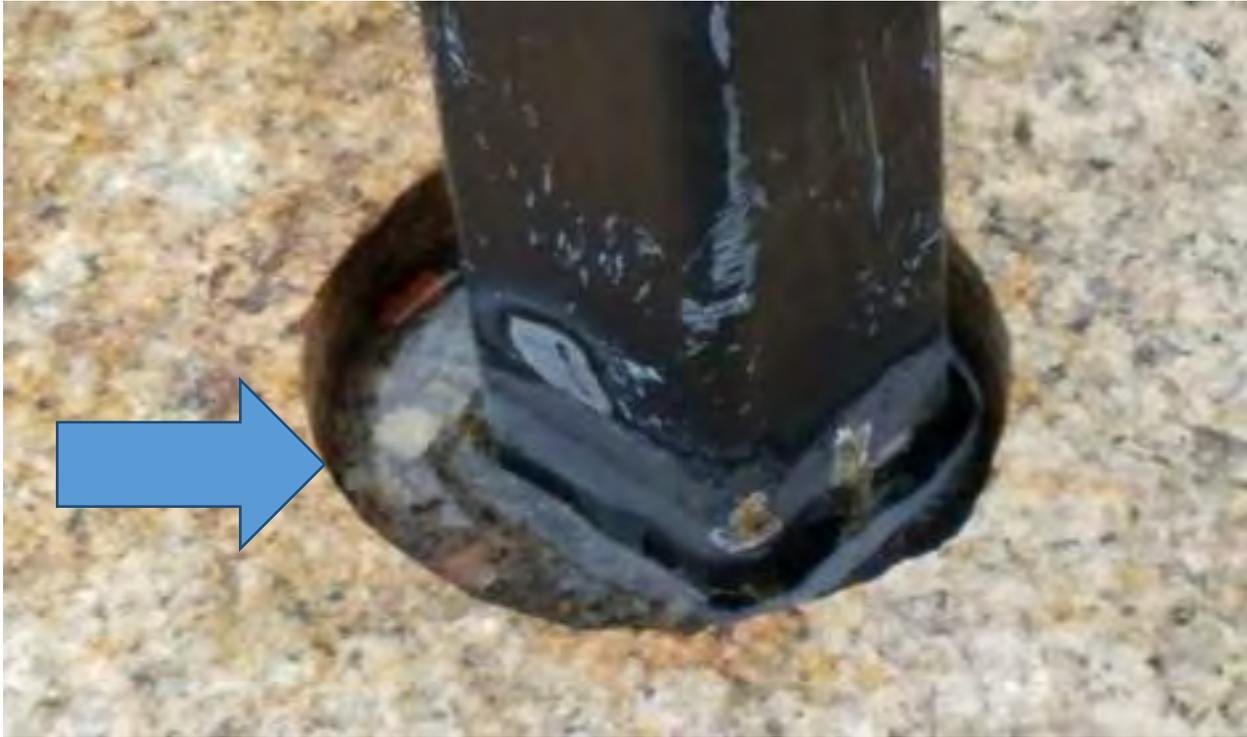
GAPS AROUND GUARDRAIL POSTS COLLECTING WATER & ICE

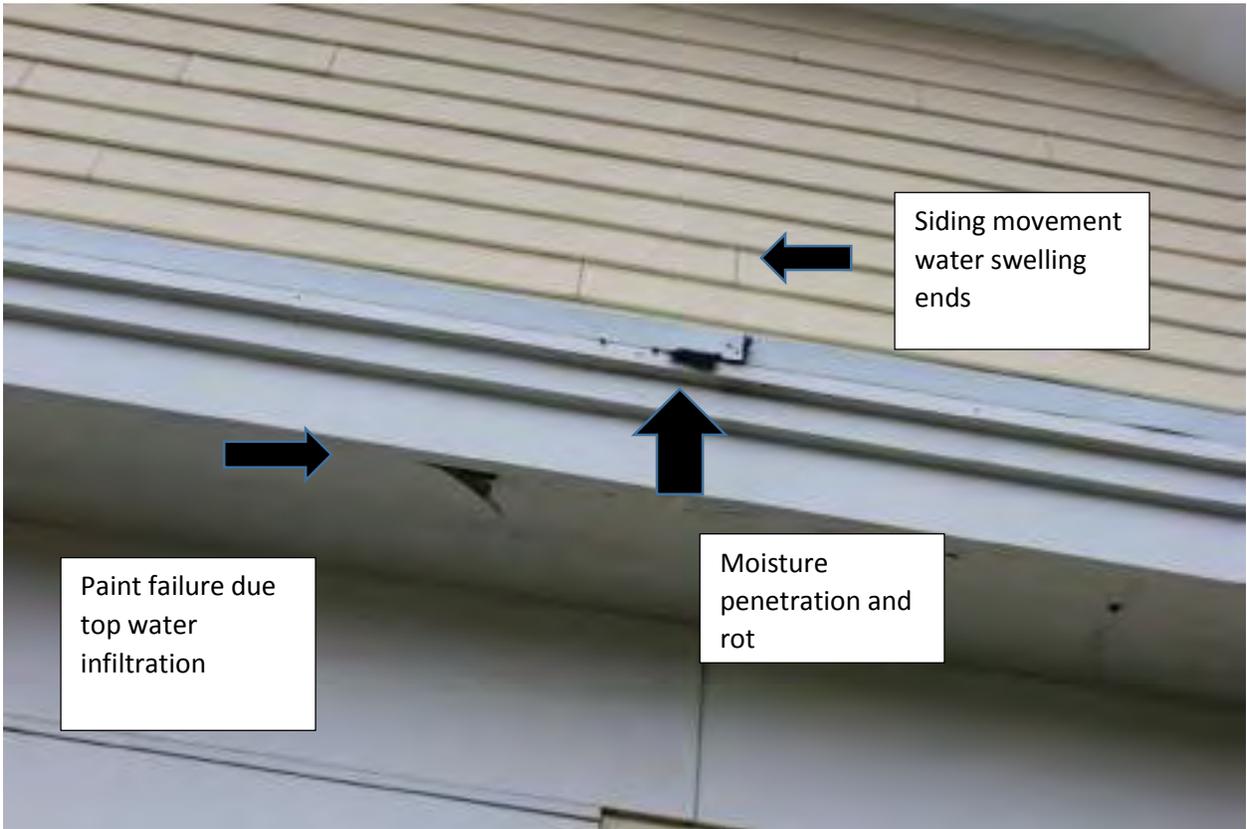
Drainage pitches to stone

Poor pipe detail allows water/rodent

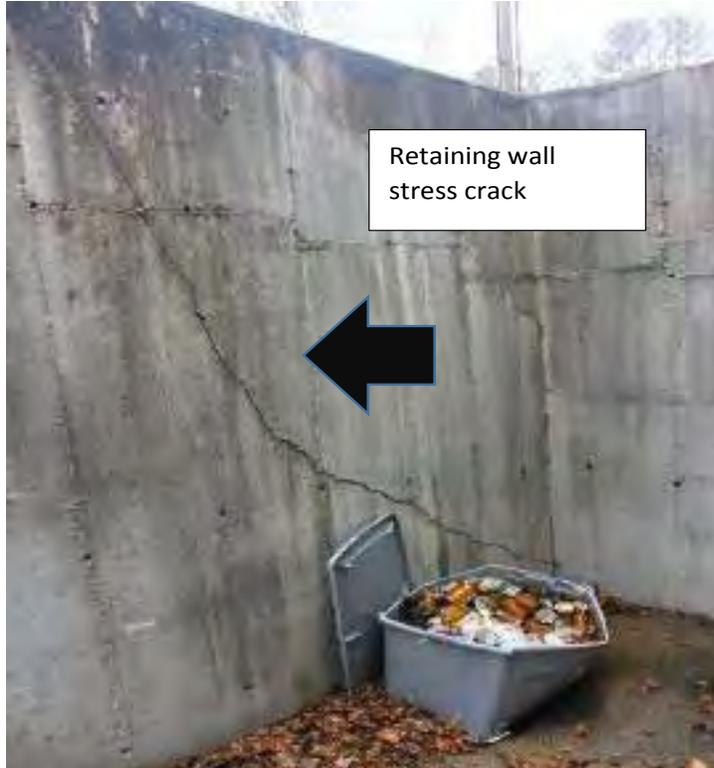
West side Ramp

On the ramp retaining wall, there is a significant vertical structural crack on the soil retaining side that runs from the top of wall to the floor of ramp which is 7’-0” long. The concrete floor of the ramp has cracking in the middle of the concrete ramp that could most likely be attributed to the expansion/contraction of the material. However, this cracking allows water penetrations into the concrete which could accelerate the concrete failure at this location.

Epoxy or mechanically fix the cracking in the retaining wall \$20,000

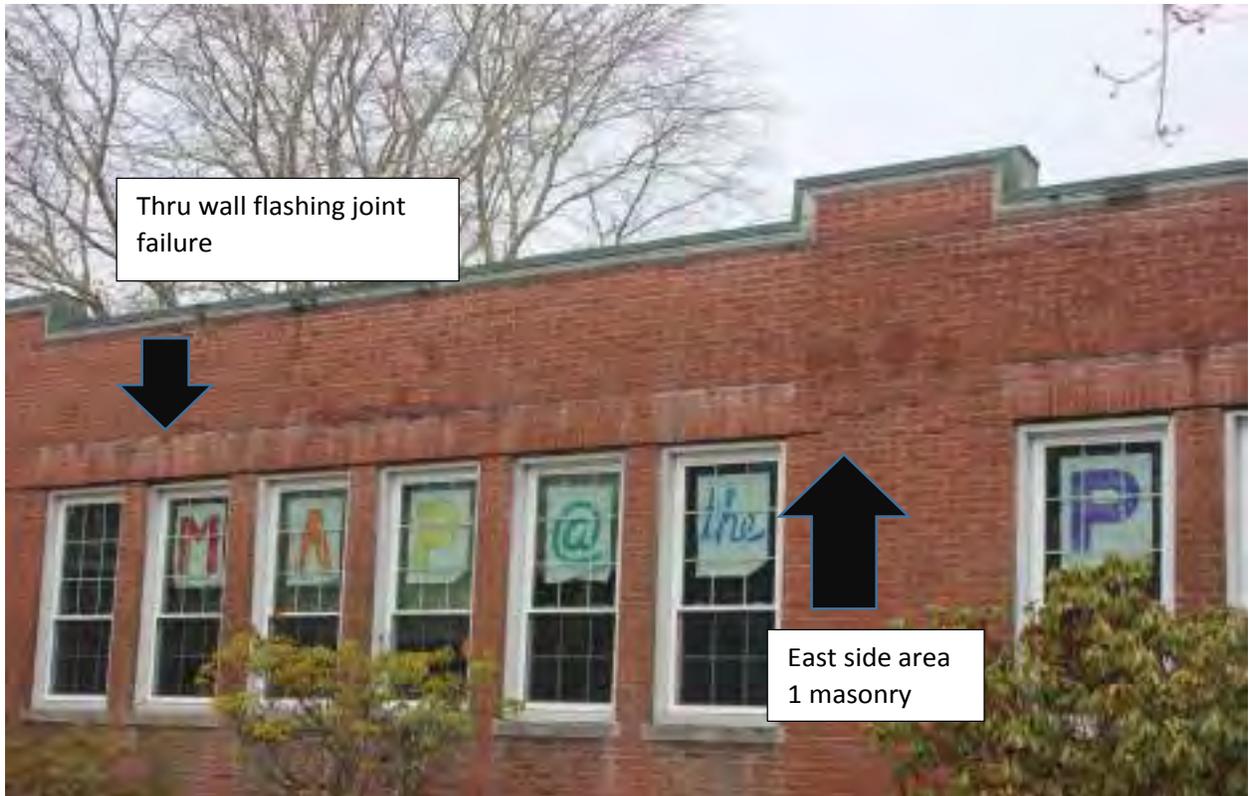
Pfaff Center

The brick is generally in fair to poor shape below the parapet wall, with areas showing signs of moisture infiltration, mortar wear, movement at all the structural steel lintels. Above the steel lintels where the wall goes from load bearing to a parapet wall is in extremely poor condition. The brick and façade and the mortar joints appear in fair to poor condition on the façades.

Moisture has infiltrated the brick at the roof parapet wall intersection. There appears to be thru wall flashing, but its condition and age may have failed. Water entering at this point, made its way to the steel lintels over the windows causing rusting and the lintels to expand. With the excess expansion of the lintels, the design which created a long thin masonry structure with no vertical anchoring, the wall appears to have “snapped” along this horizontal joint. Large structural cracking has opened gaps as large as one inch in the masonry wall, thus allowing more water penetration and accelerating rusting and failure. This excess water within the brick cavity is subject to freeze thaw cycles at the face. The freezing moisture has expanded and at the face of the brick spalled the face of the brick. At the brick

interface, the mortar joints are failing due to the different absorption rate and expansion rate of the materials. There are significant signs of movement at this critical joint.

Structural/exterior envelope engineering review. The structure has such significant problems in the masonry wall at the parapet and lintel locations, and engineer review is needed immediately. See 3.2 Super structure

Masonry, flashing, repointing and structural repair as determined by the engineering review. See 3.2 Super structure

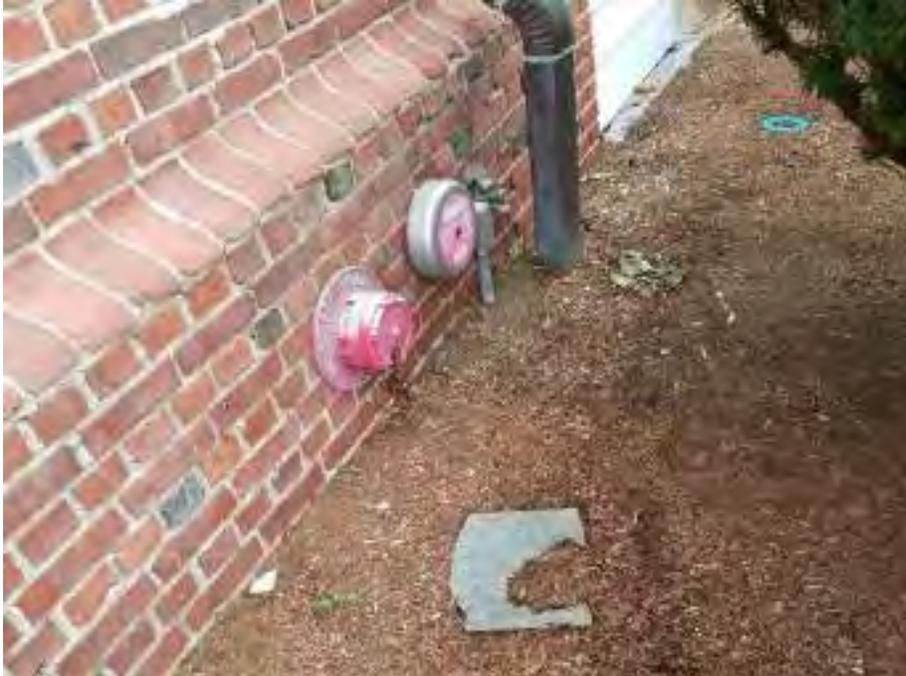
SHOWING DEMINISHED ACCESS TO FIRE DEPARTMENT CONNECTION (WEST)
(NOTE FALLEN ROOF SLATE IN FOREGROUND)

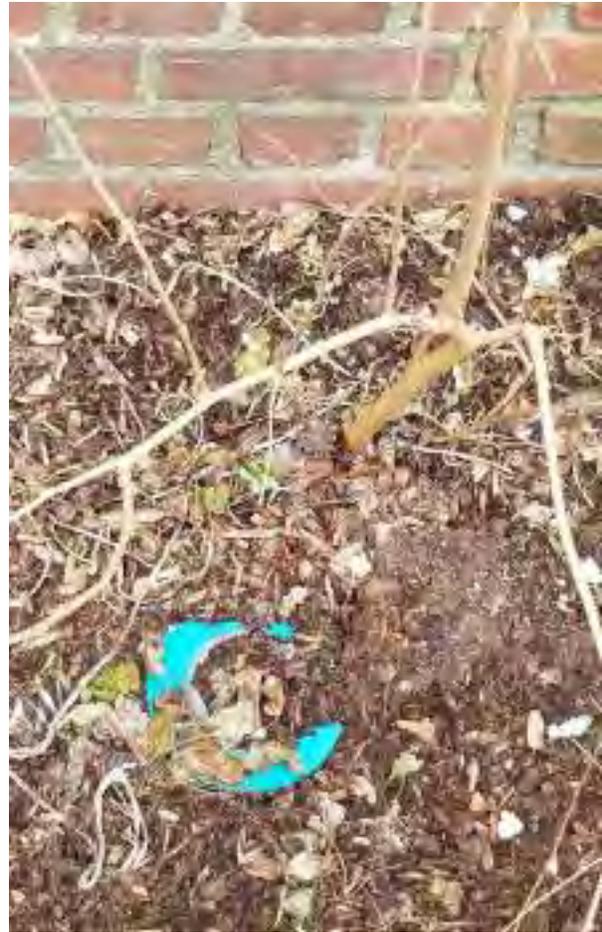
LANDSCAPING LIGHT NOT FUNCTIONING

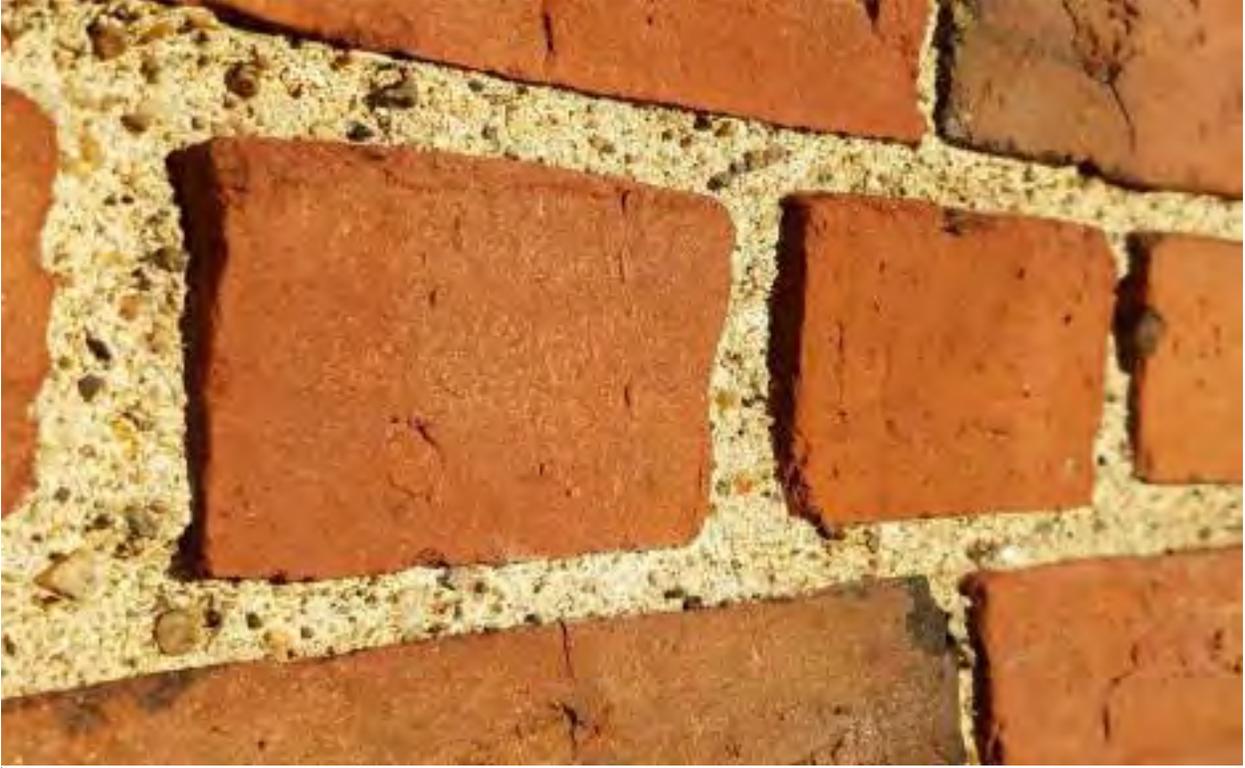
CLOSE-UP OF ORIGINAL MORTAR JOINTS SHOWING COURSE TEXTURE and WIDE SPREAD EFFLORESCENCE

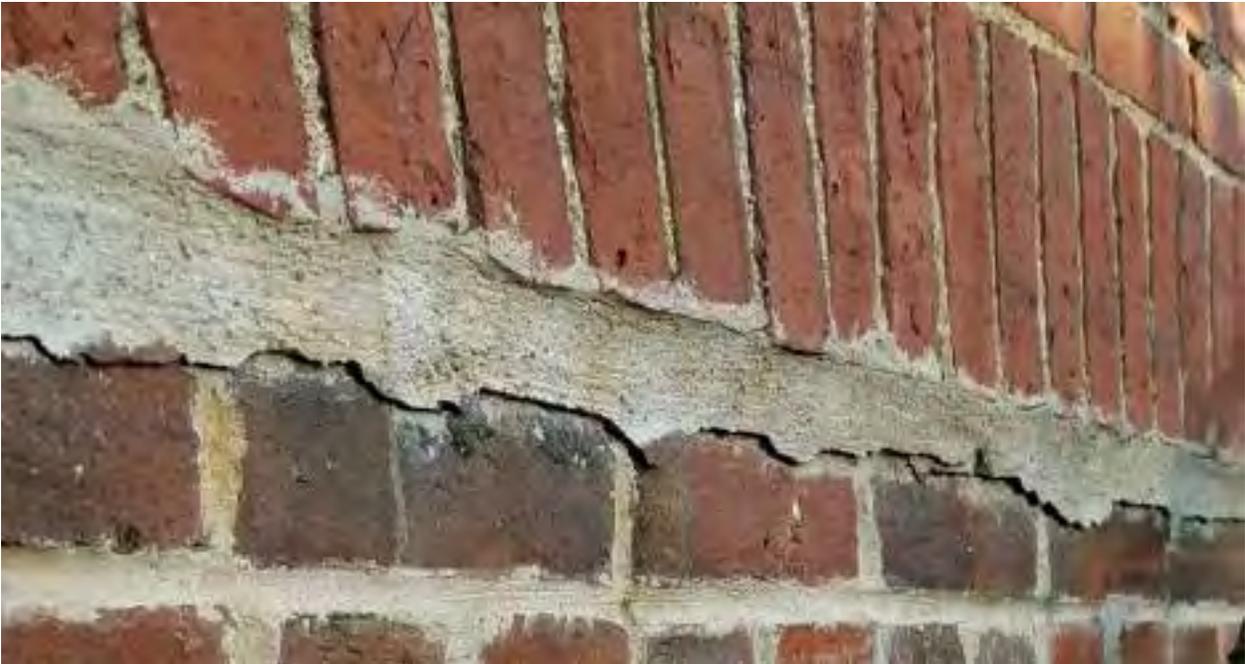
POORLY EXECUTED REPOINTING (WEST ELEVATION)

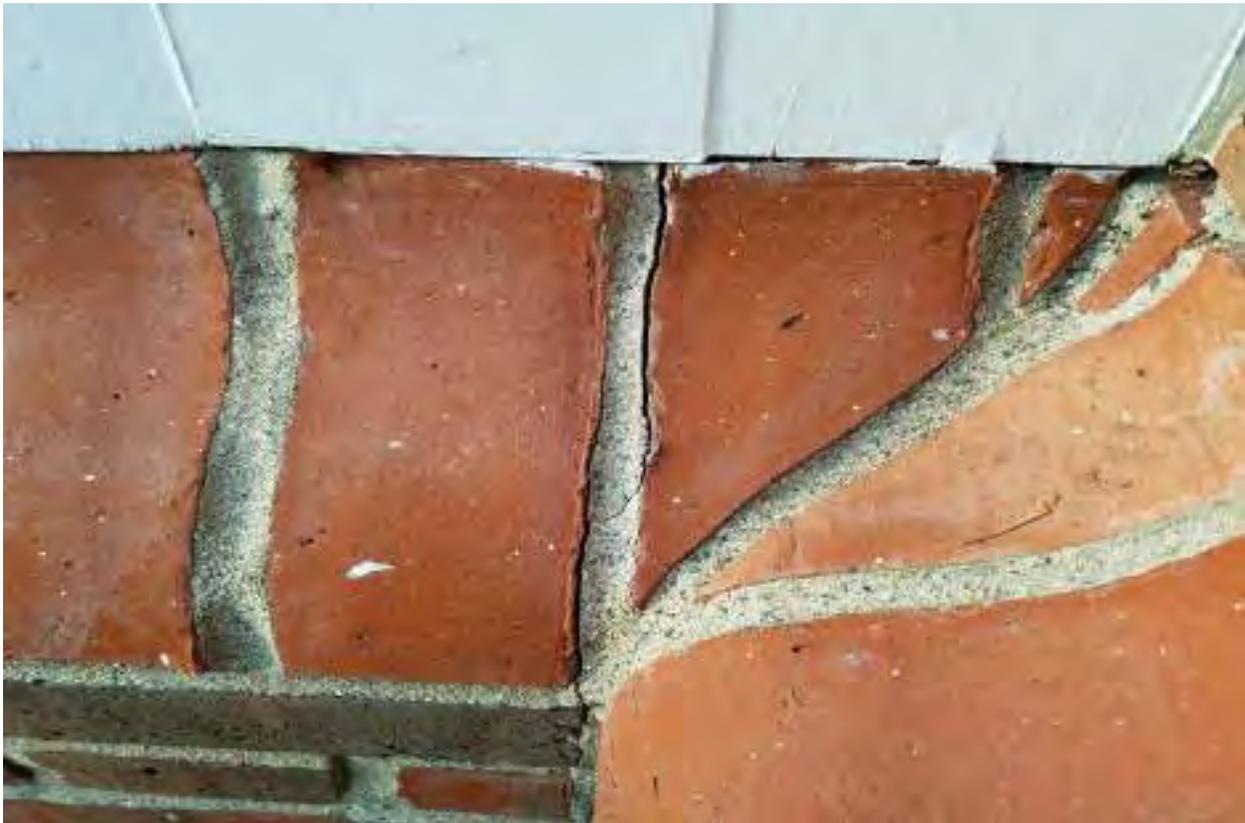
TYPICAL OPEN JOINTS IN WATER TABLE BRICK JOINTS NEEDING REPOINTING

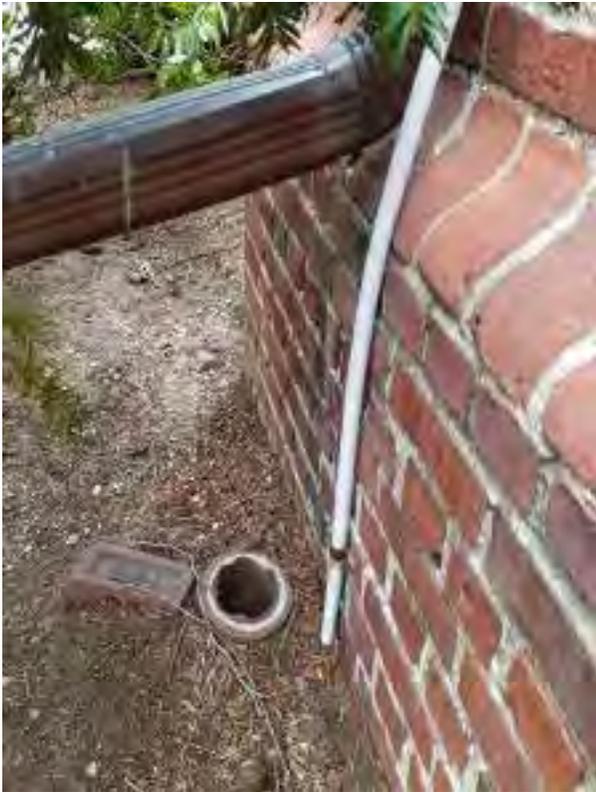
UNCONNECTED DOWNSPOUT

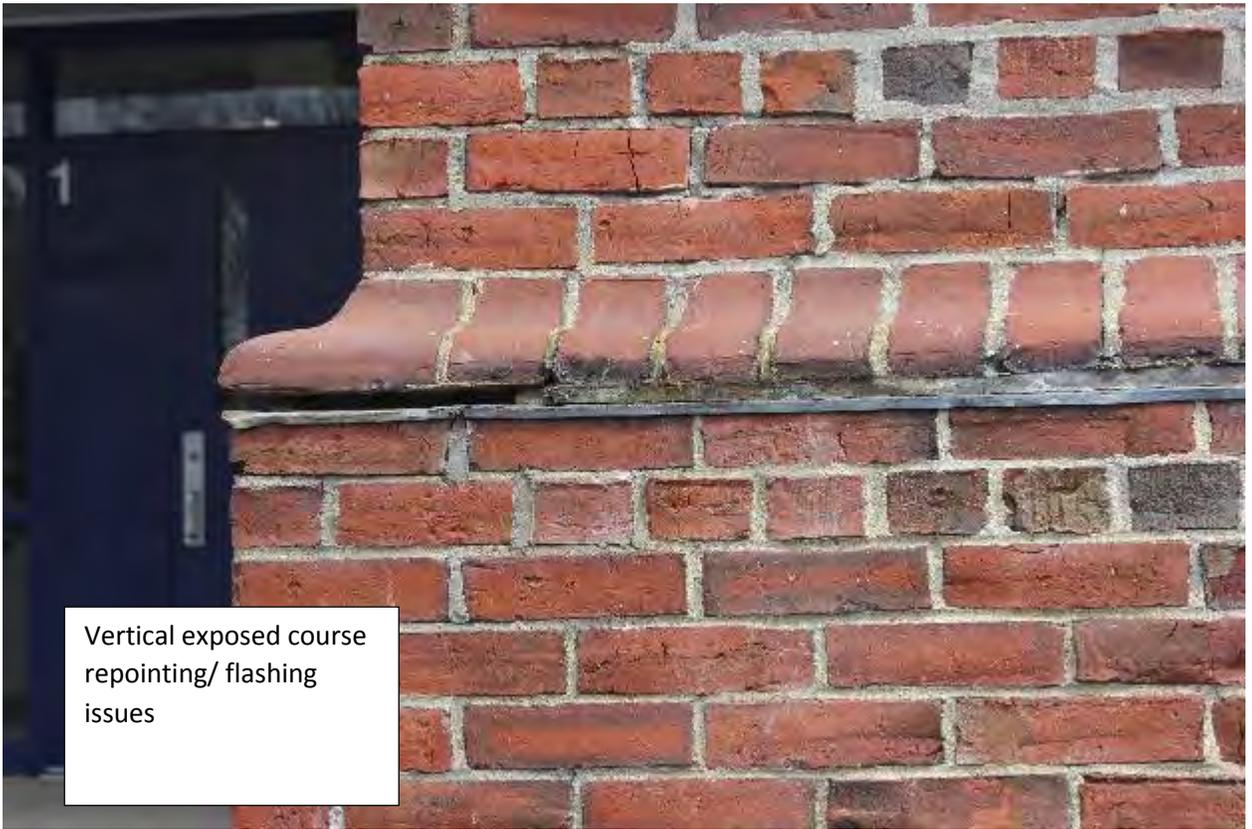
Vertical exposed course
repointing/ flashing
issues

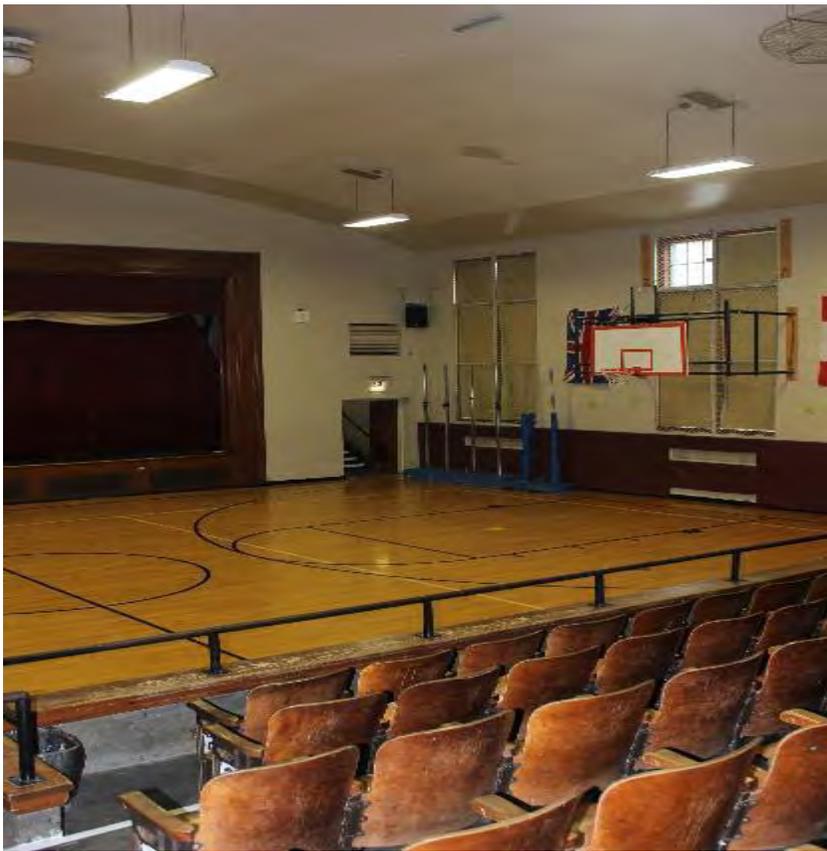
Dated interior fixtures
